September 13, 2004

**RE: LIMITED PHASE II ENVIRONMENTAL SITE ASSESSMENT  
U.S. DEPARTMENT OF AGRICULTURE  
AGRICULTURAL RESEARCH SERVICE FACILITIES  
4331 and 4135 EAST BROADWAY ROAD  
PHOENIX, ARIZONA**

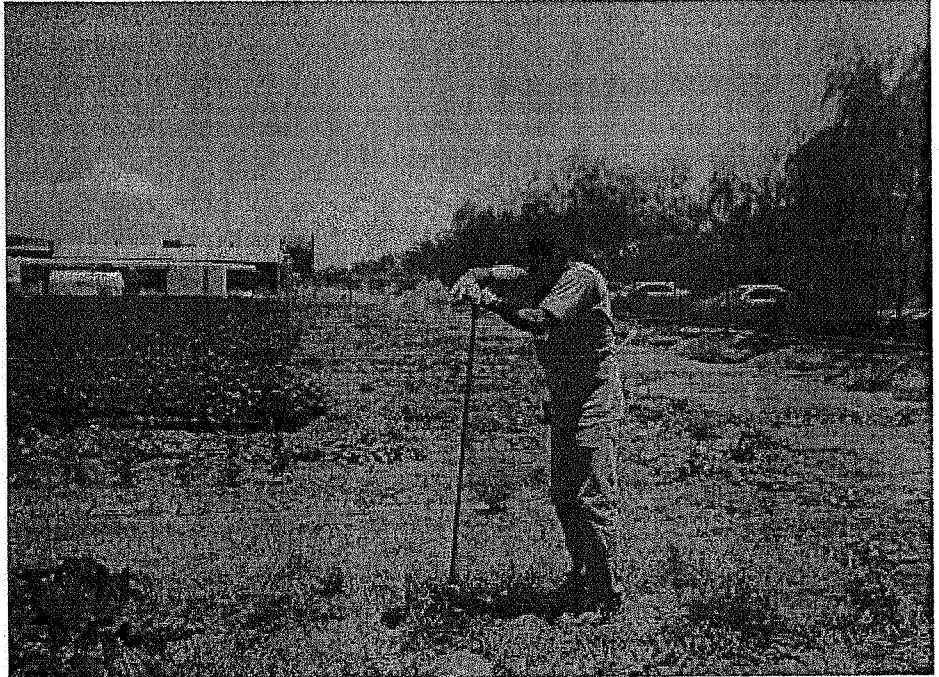
### **Photograph No. 1**

**Description:** View of ITSI personnel collecting a soil sample from the agriculture field on Property 4135.

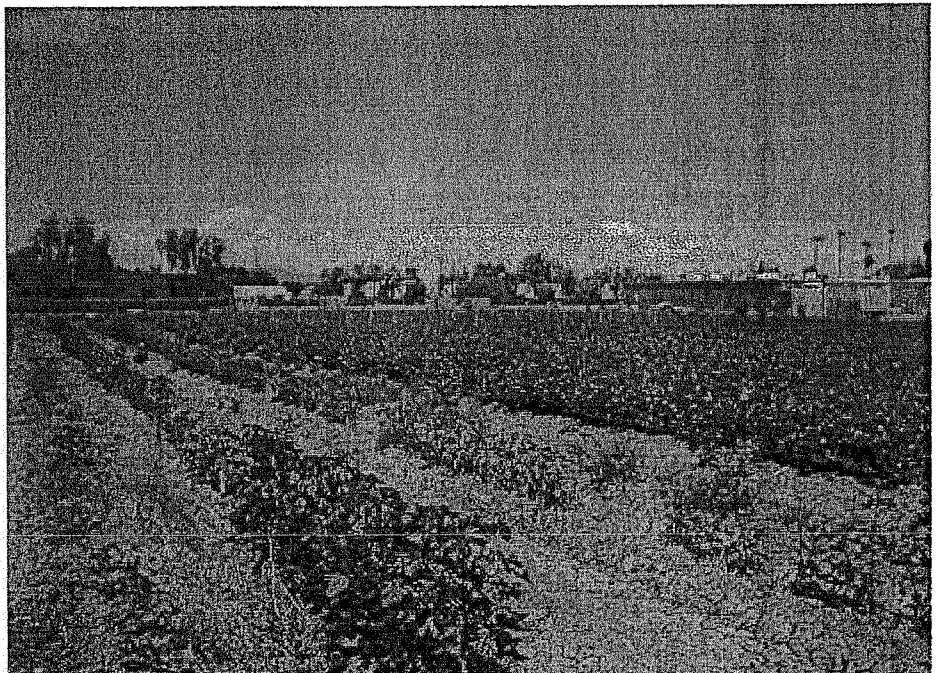
### **Photograph No. 2**

**Description:** View of the agricultural field at Property 4135.

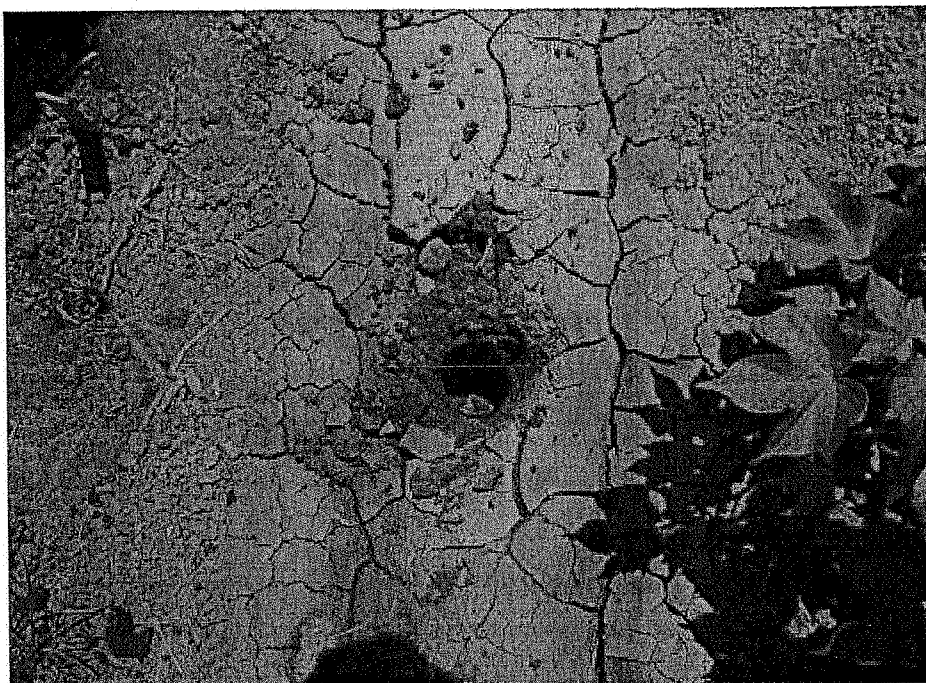
### **Photograph No. 3**

**Description:** Close up view of a sub-sample location on agricultural field at Property 4135.

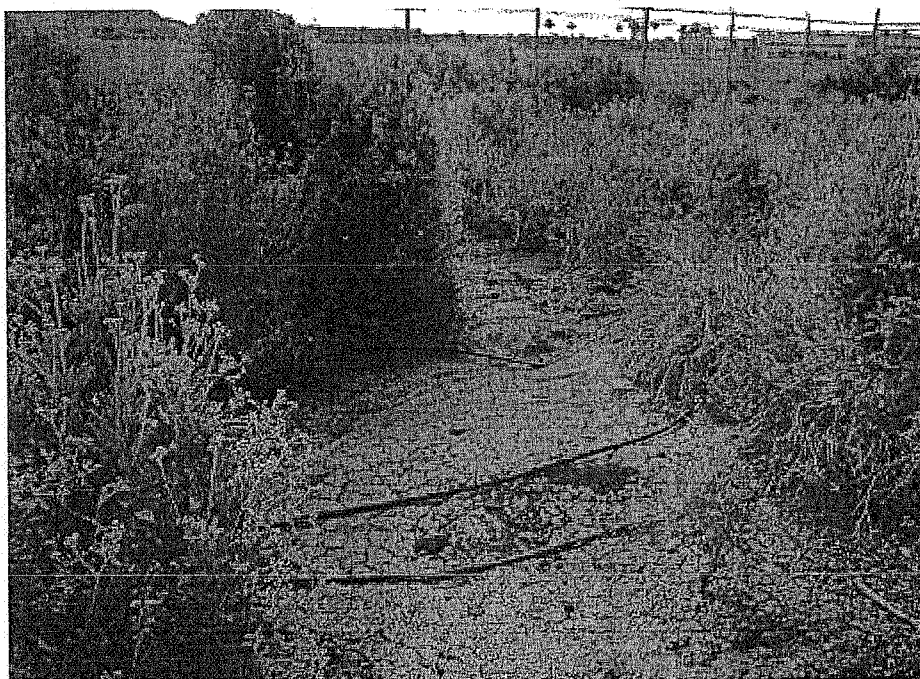
### **Photograph No. 4**

**Description:** View of a sub-sample location on the agricultural field located at Property 4331.

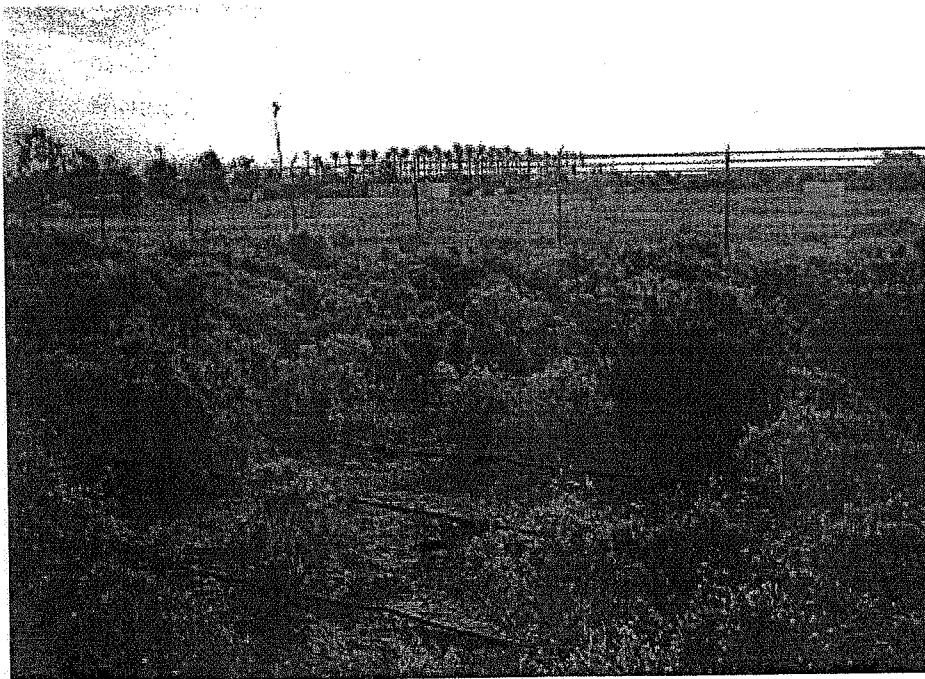
### **Photograph No. 5**

**Description:** View of a sub-sample location on the agricultural field located at Property 4331.

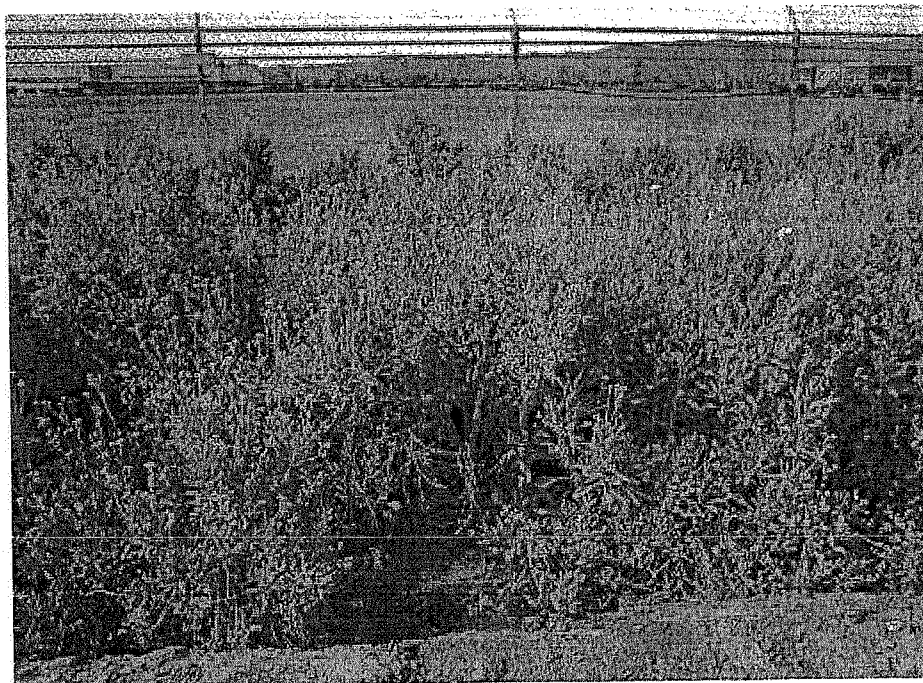
### **Photograph No. 6**

**Description:** View of a sub-sample location on the agricultural field located at Property 4331.

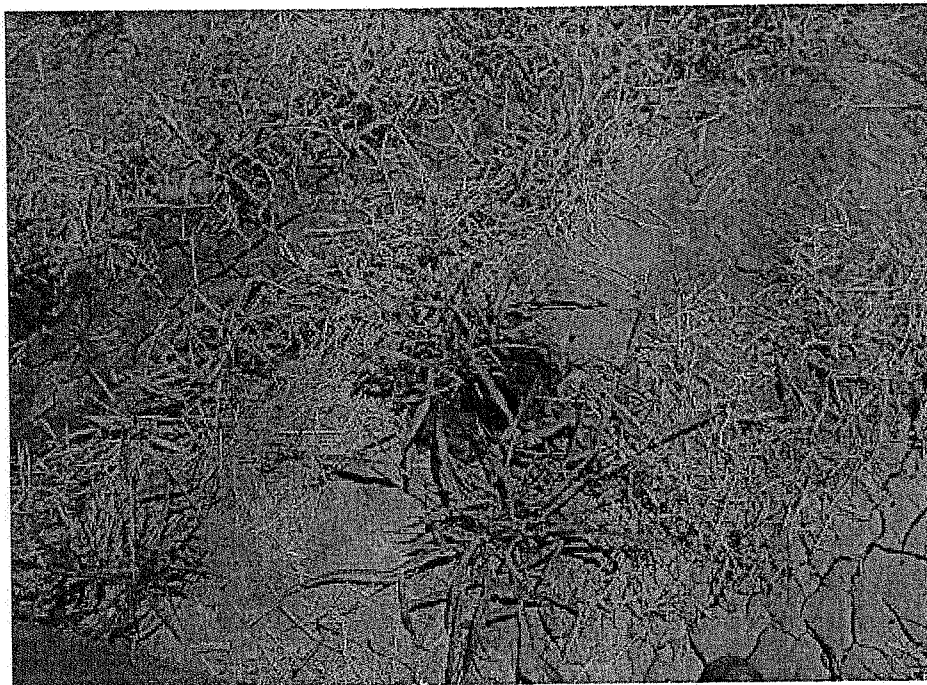
### **Photograph No. 7**

**Description:** View of a sub-sample location on the agricultural field located at Property 4135.

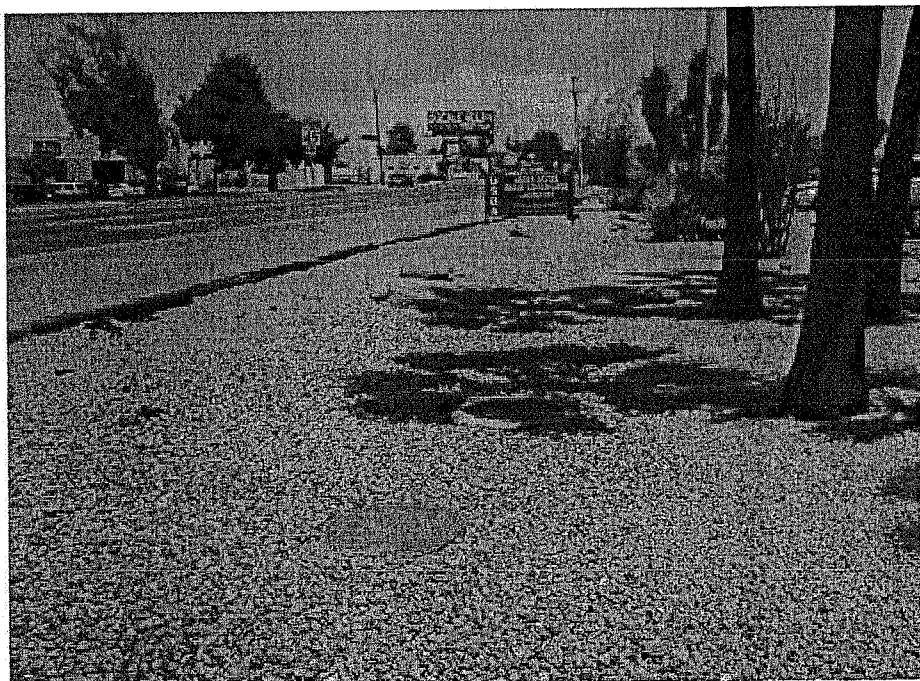
### **Photograph No. 8**

**Description:** View of a suspected septic tank in front of Property 4331.

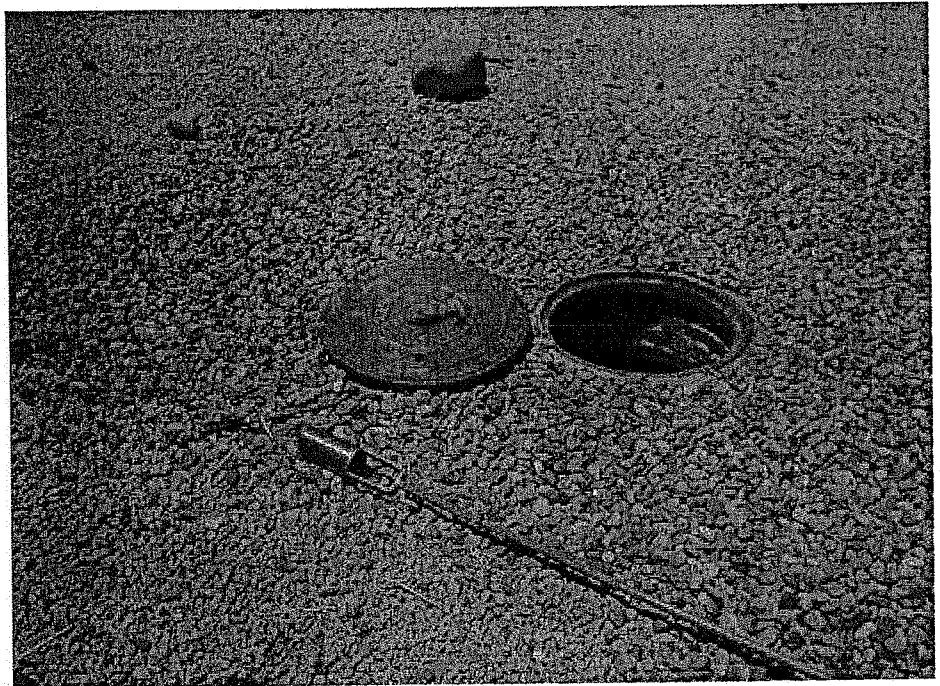
### **Photograph No. 9**

On July 12, 2004, ITSI attempted to collect a sludge sample from the base of the suspected septic tank located in front of the main building at Property 4331. ITSI removed the two manhole covers originally identified as covering the septic tank. Standing water was observed in the bottom of both pits. Upon further examination, it appeared that septic system may now be connected to the COP sanitary sewer system. ITSI attempted to collect a sludge sample from the tank by lowering a hand auger into the base of the tank. However, ITSI was unable to collect a sludge sample for analysis. A decision was made to return the next day with a bailer and collect a water sample to be analyzed for the same parameters.

**Description:** ITSI was unable to collect a sludge sample from the suspected septic tank at Property 4331.

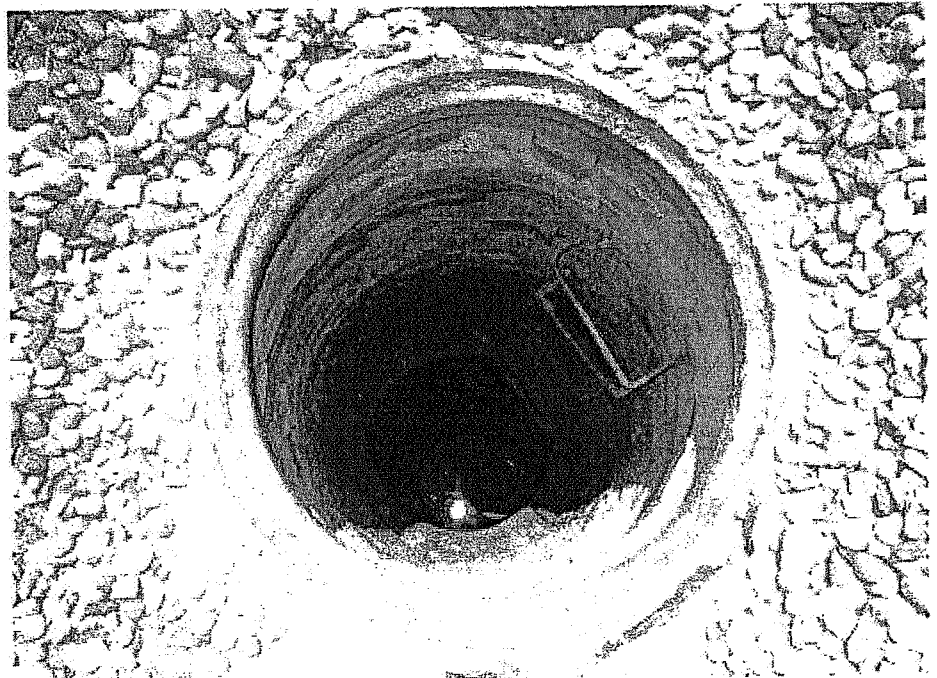
### **Photograph No. 10**

Analytical results for the water sample collected from the suspected septic tank, ST-4331-01, were below laboratory detection limits for all parameters with the exception of barium and cadmium at 0.12 milligrams per liter (mg/L) and 0.0057 mg/L, respectively (Table 2).

**Description:** Interior view of the suspected septic tank at Property 4331 (Note: Notice the free standing water at the bottom).

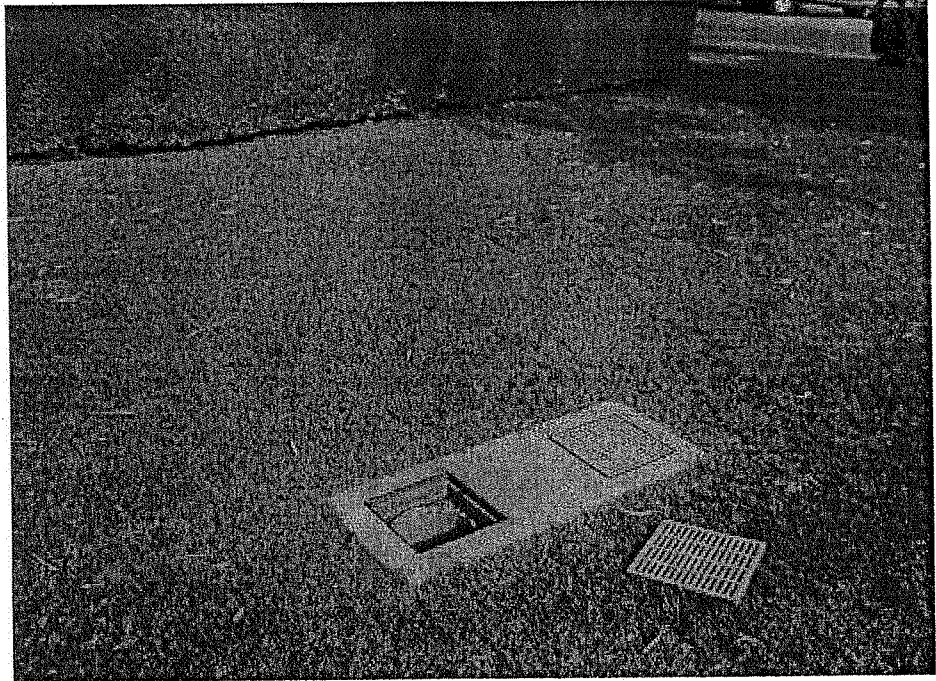
### **Photograph No. 11**

During ITSI's Phase I ESA site reconnaissance of Property 4331, a dry well was identified located in a courtyard surrounded by an asphalt paved parking lot and portable office trailers. The dry well was designed to receive storm water runoff from the parking lot and rain gutters from the surrounding buildings. In addition to the dry well at Property 4331, a suspected septic tank was observed near the northwest corner of the property fronting Broadway Road. According to site information obtained during the Phase I ESA, the septic tank was used prior to the City of Phoenix (COP) Sanitary Sewer System being available along Broadway Road. The facility has since switched over to the COP sanitary sewer system.

**Description:** View of dry well  
in the courtyard at Property 4331.

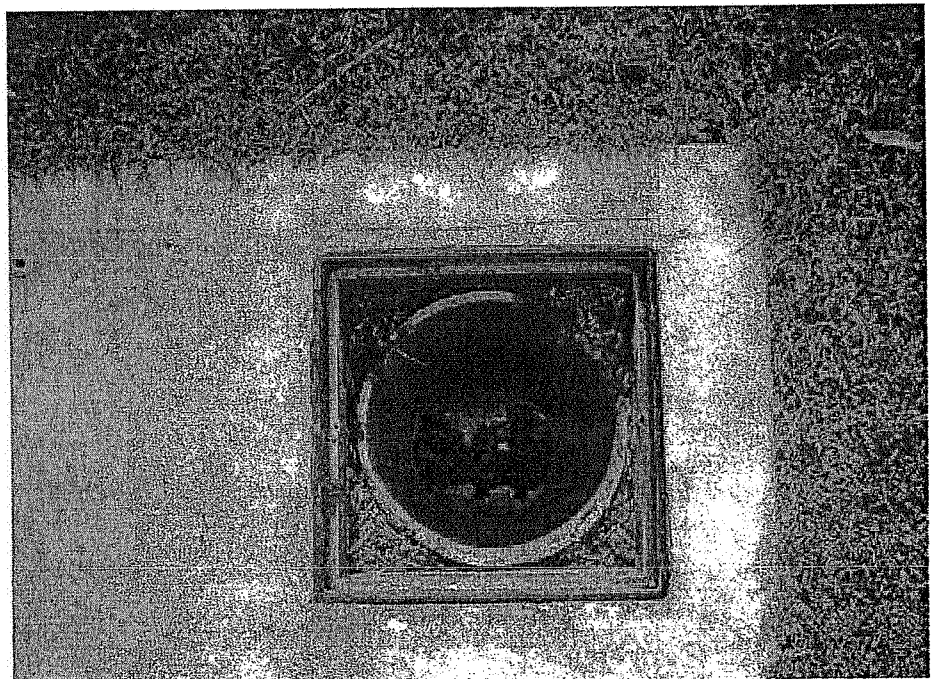
### **Photograph No. 12**

Analytical results for the soil/sludge sample collected from the dry well, DW-4331-01, indicated trace amounts of barium, cadmium, chromium, lead, and trichlorofluoromethane (Table 2). All results were below ADEQ residential SRLs. All other parameters were below laboratory detection limits.

**Description:** Interior view of  
the dry well in the court yard at  
Property 4331.
